Your Inspection Report

1234 Sunshine Place
Okanagan, BC V1B 2Y3

INSPECTION DATE:
Sunday, May 5, 2013

RE: Report No. 1597, v.3
1234 Sunshine Place
Okanagan, BC
V1B 2Y3

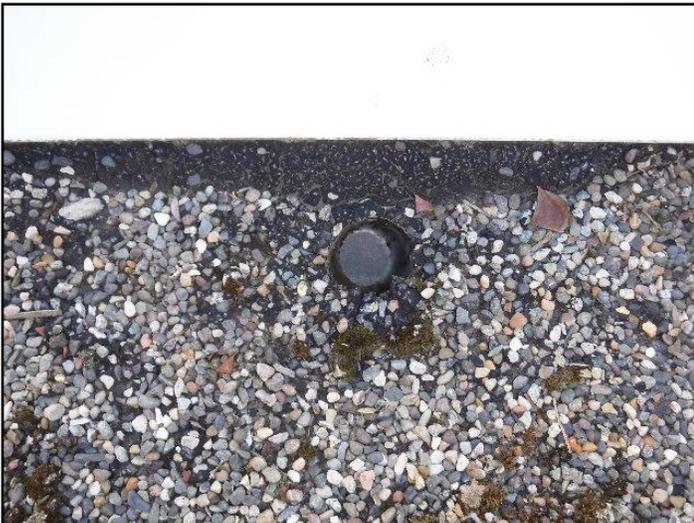
Condition: • Near end of life expectancy

Tar and gravel roofing on stairwell enclosure is old and worn out, recommend replacement by roofer.

1. Near end of life expectancy

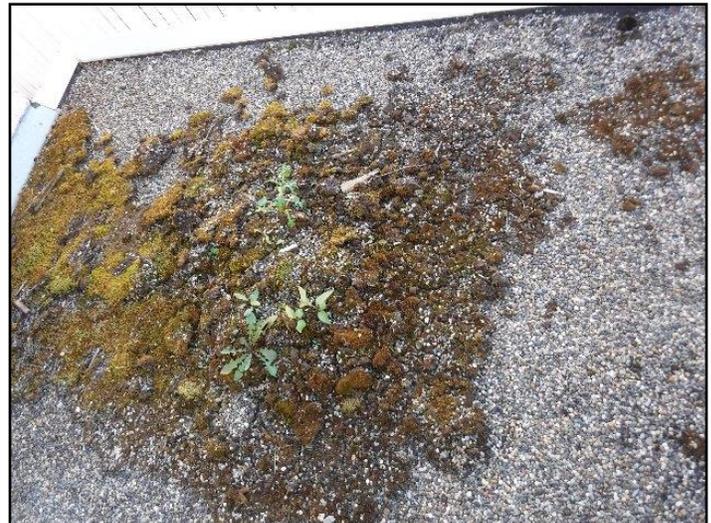
2. Near end of life expectancy

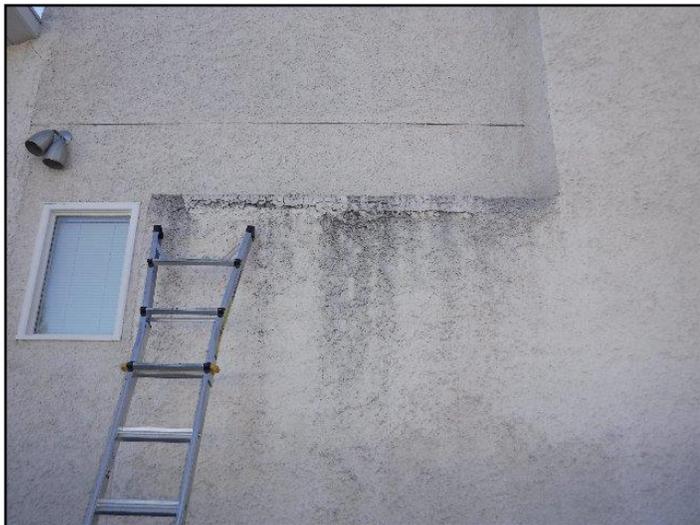
Moisture penetration through stucco was observed on West exterior wall, recommend further evaluation and repair by contractor.

3. Moisture penetration

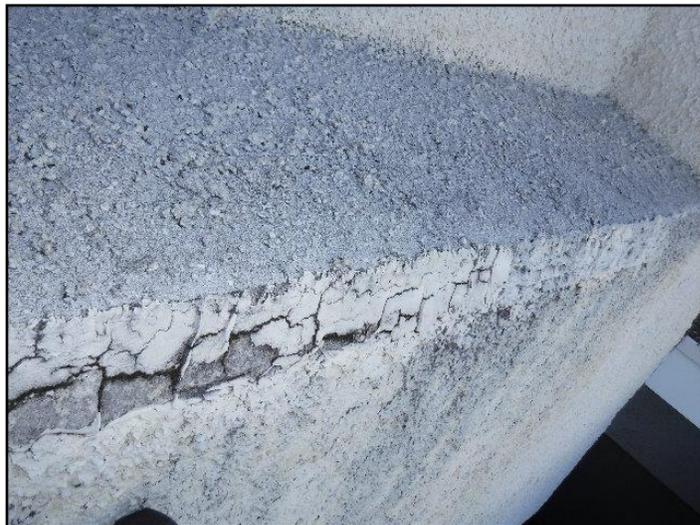
4. Moisture penetration

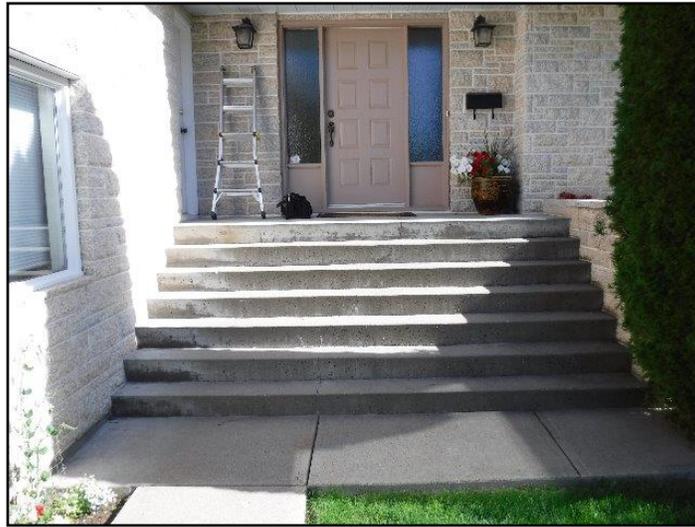
Handrail installation is recommended for front exterior steps.

5. Missing

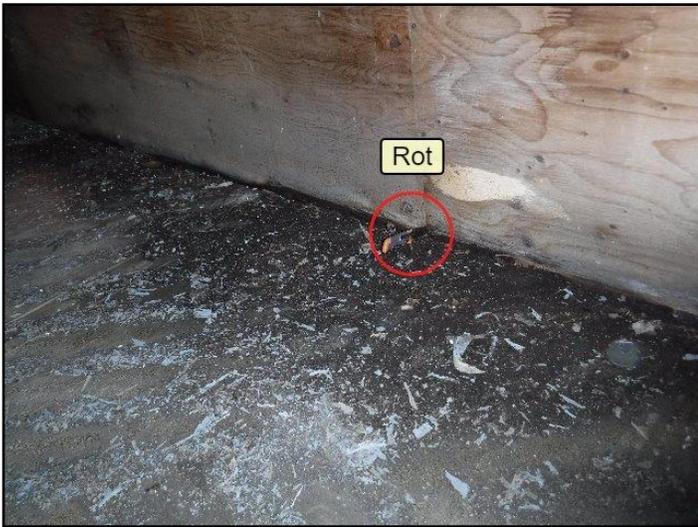
Wood frame walls of North addition are too close to grade and water coming through exterior deck above is pooling against wall promoting rot. Recommend contractor repairs or improvements to avoid further damage.

6. Wood too close to grade

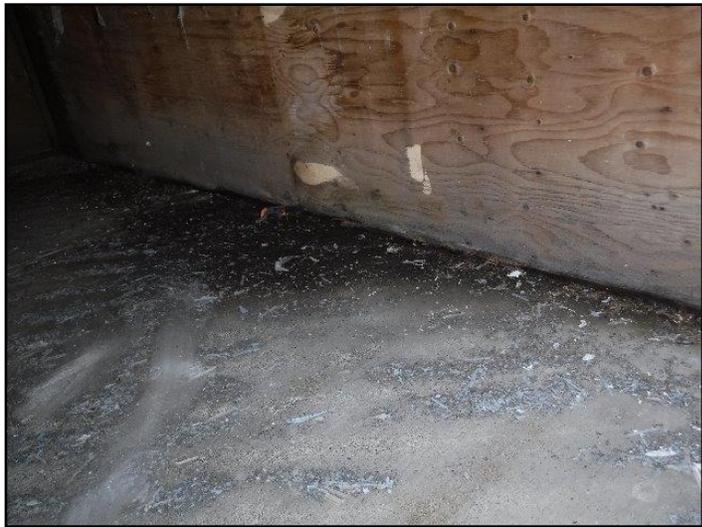
7. Wood too close to grade

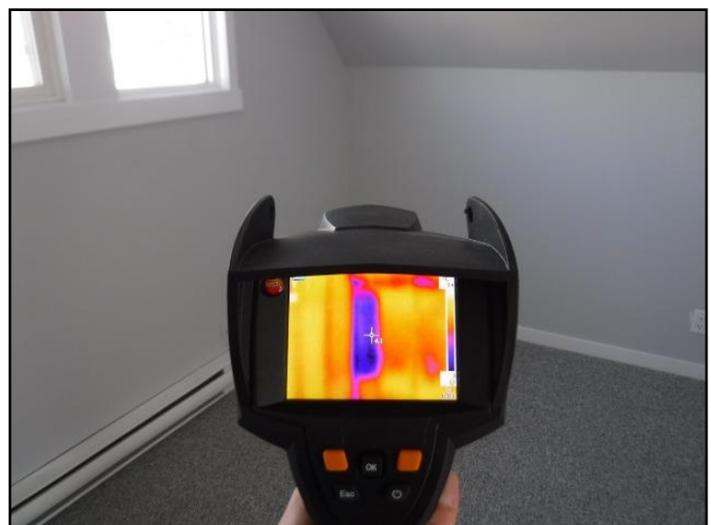
Condition: • An anomaly what appears to be missing or water damaged insulation was detected with thermal camera in second floor bedroom walls. Water damage from previous roof leakage is suspected to have occurred in these areas, recommend having further evaluation or testing for concealed damage before removing subjects on property.

9. Southwest corner of bedroom

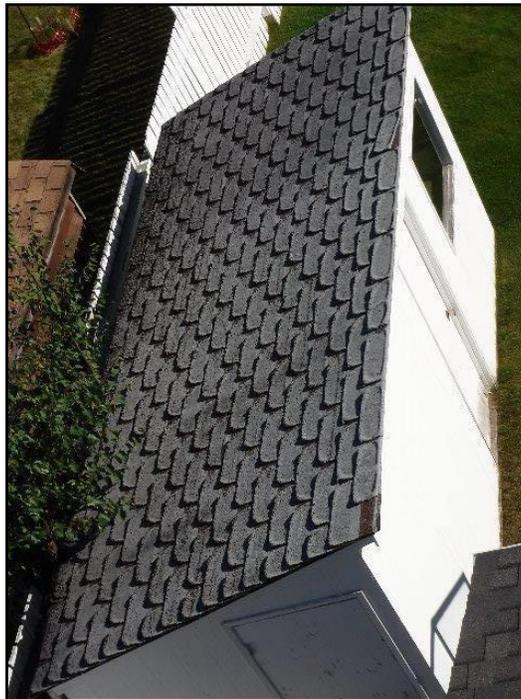
1. Condition: • Old, worn out

14. Old, worn out (shed)

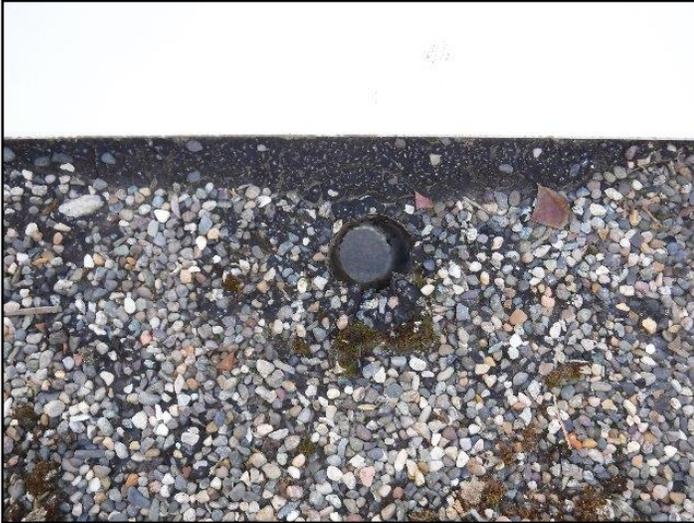
3. Condition: • Near end of life expectancy

Tar and gravel roofing on stairwell enclosure is old and worn out, recommend replacement by roofer.

15. Near end of life expectancy

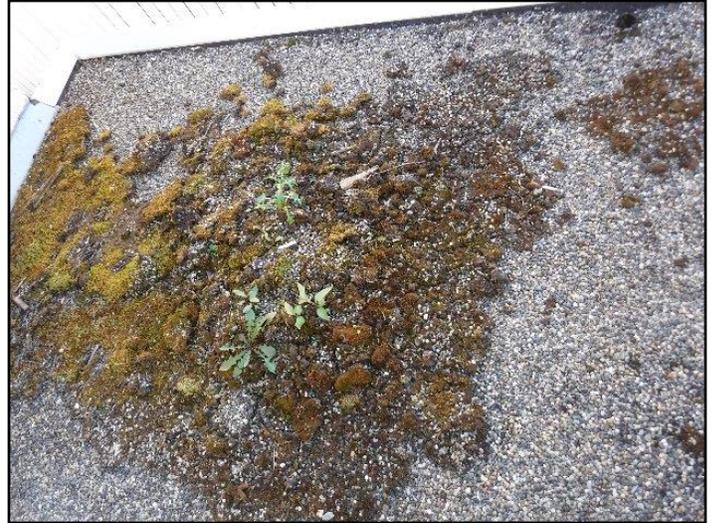
16. Near end of life expectancy

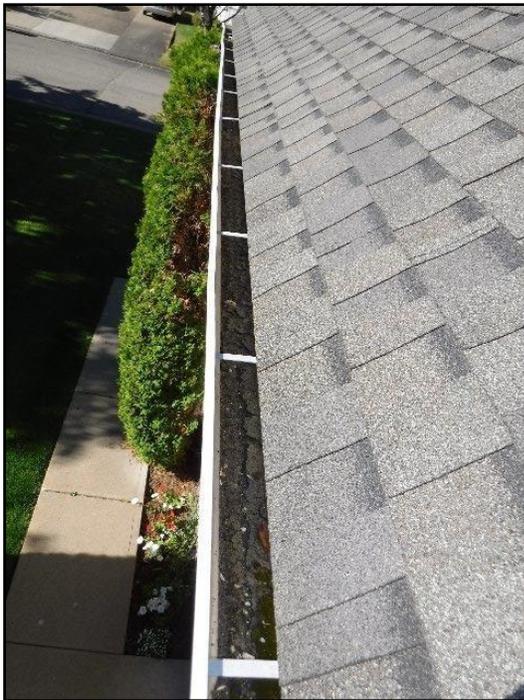
4. Condition: • Clogged

17. Clogged

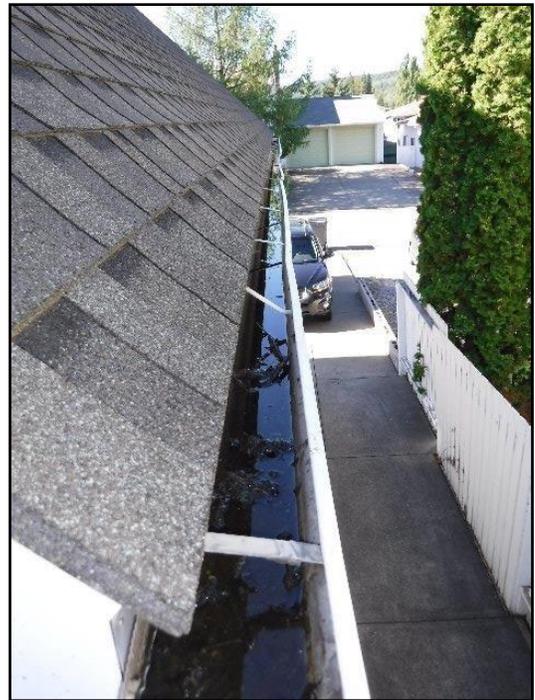
18. Clogged

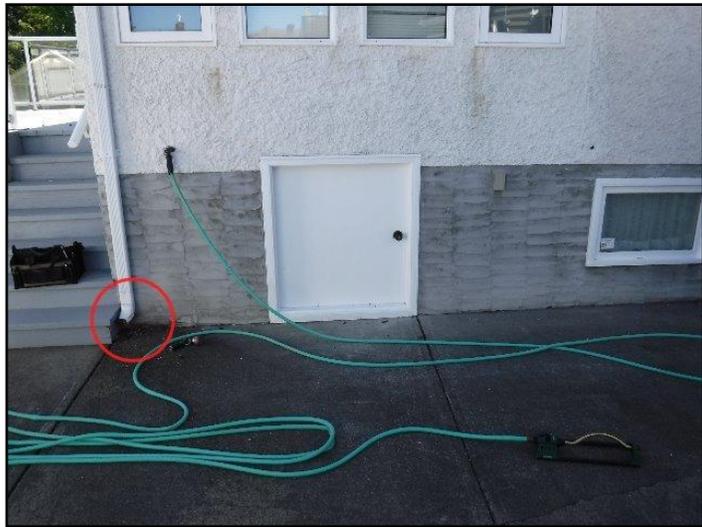
This downspout is causing water damage to foundation parging and wood steps, recommend re-routing away from building.

19. Downspouts end too close to building

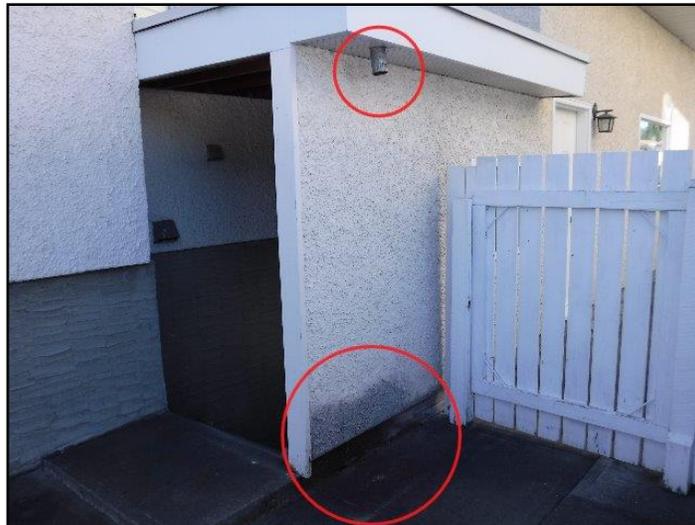
6. Condition: • Missing
 Moisture penetration at bottom of stair enclosure wall is present due to missing downspout, recommend further evaluation and repair by contractor.
Implication(s): Chance of water damage to contents, finishes and/or structure
Location: Left Side Exterior
Task: Correct
Time: Immediate

20. Missing

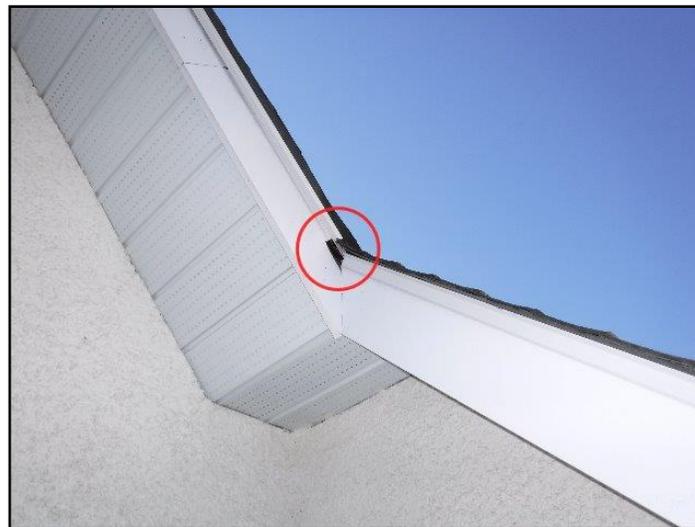
7. **Condition:** • Loose or missing pieces

21. Loose or missing pieces

Recommend repair to prevent unwanted pests entering roof space.

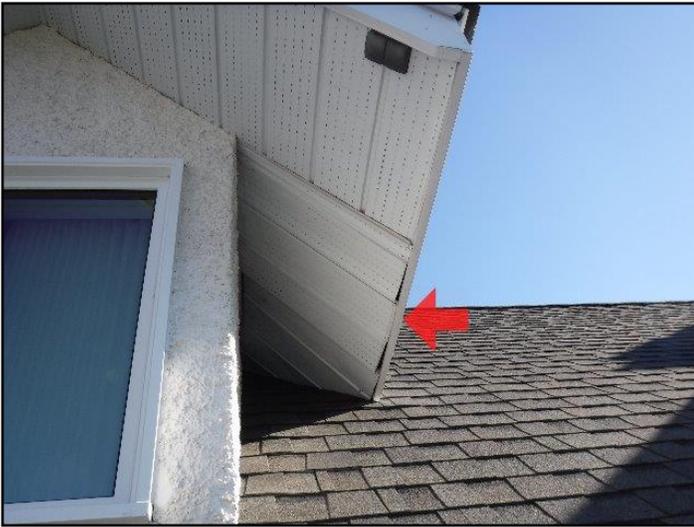
8. Condition: • Loose or missing pieces

22. Loose or missing pieces

Recommend repair to prevent unwanted pests entering roof space.

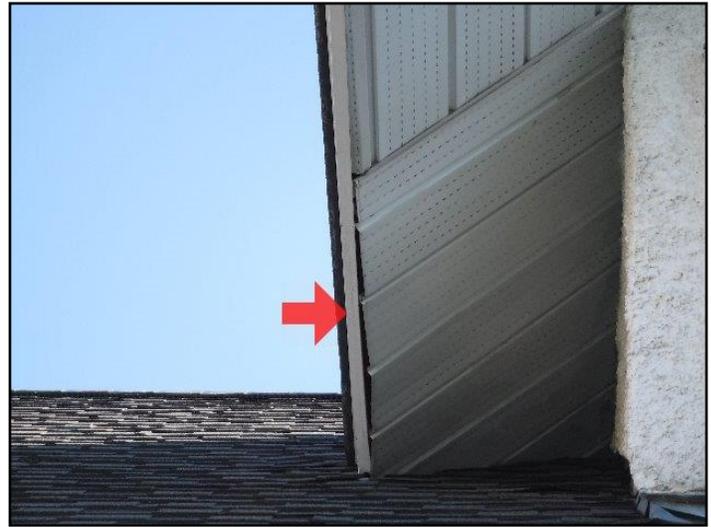
23. Loose or missing pieces

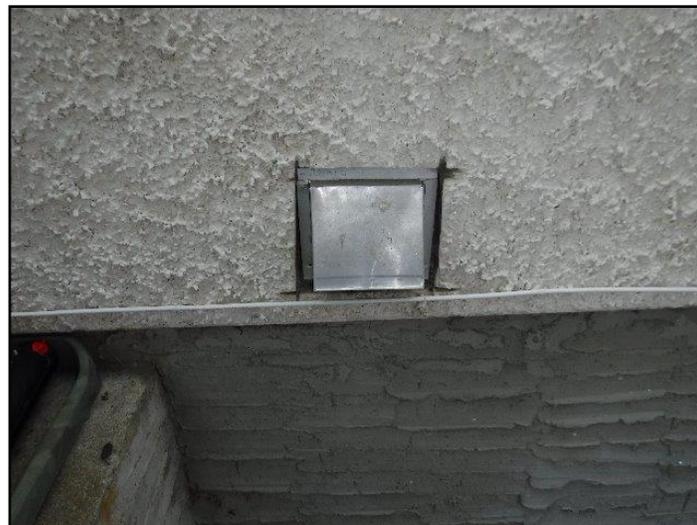
9. Condition: • Caulking missing or deteriorated

24. Caulking missing or deteriorated

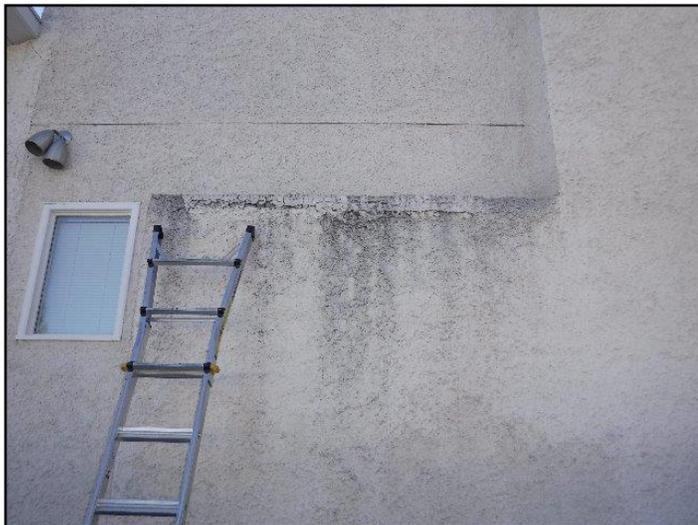
Moisture penetration through stucco was observed on West exterior wall, recommend further evaluation and repair by contractor.

25. Moisture penetration

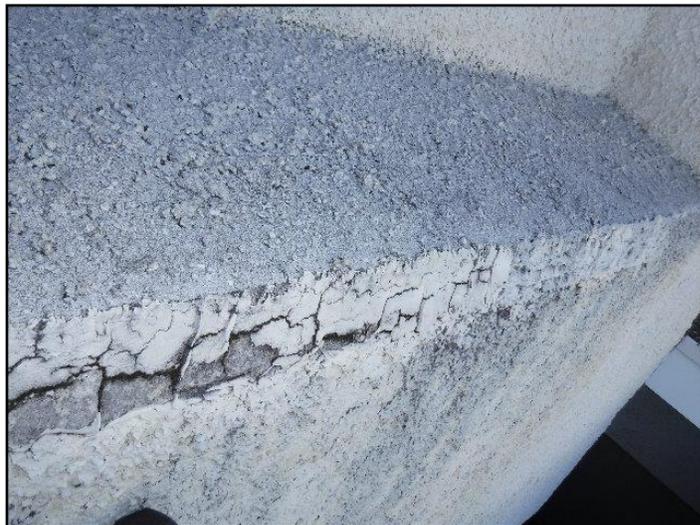
26. Moisture penetration

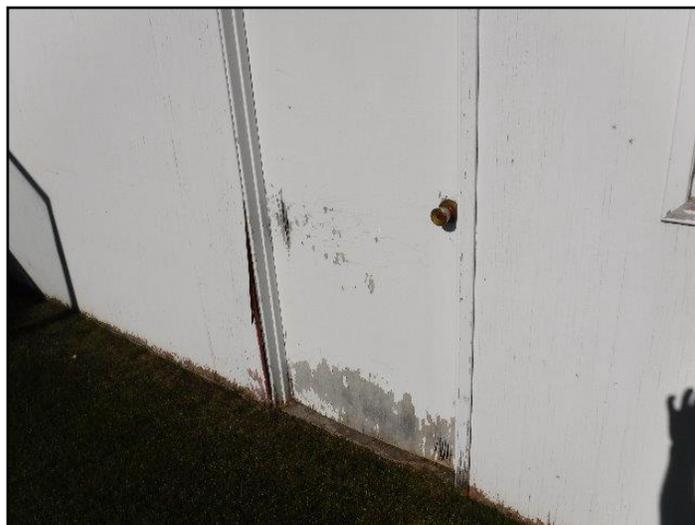
11. Condition: • Delaminated

27. Delaminated (shed)

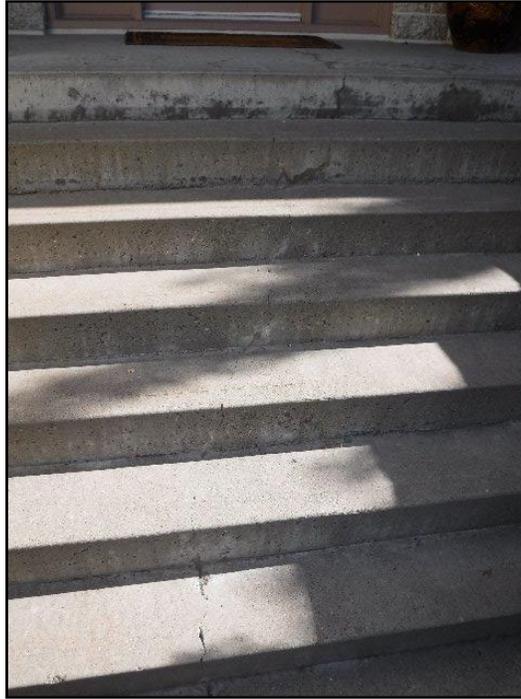
12. Condition: • Masonry or concrete cracking

28. *Masonry or concrete cracking*

Recommend sealing of cracks to avoid further damage

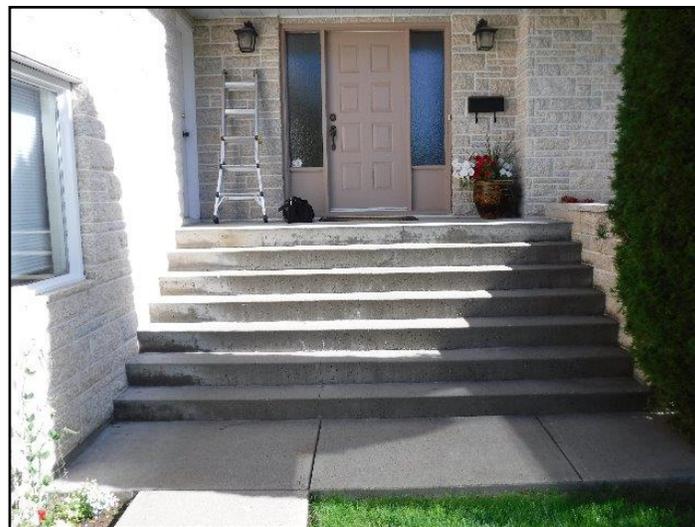
Handrail installation is recommended for front exterior steps.

29. Missing

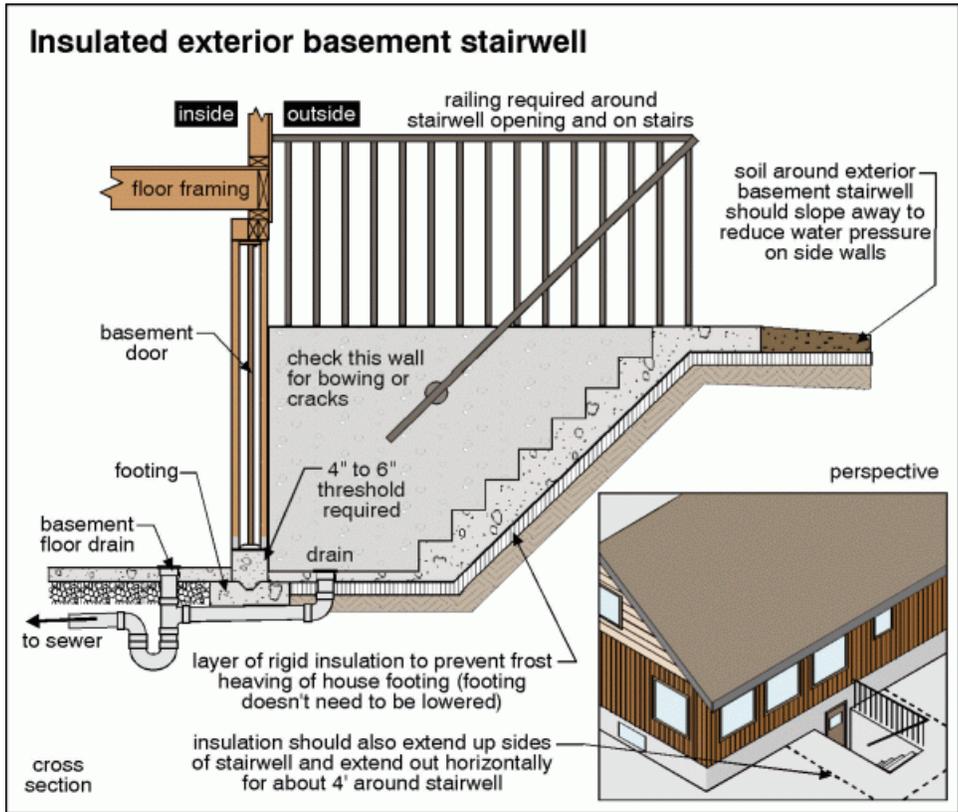
14. Condition: • Guard and handrail problems

30. Guard and handrail problems

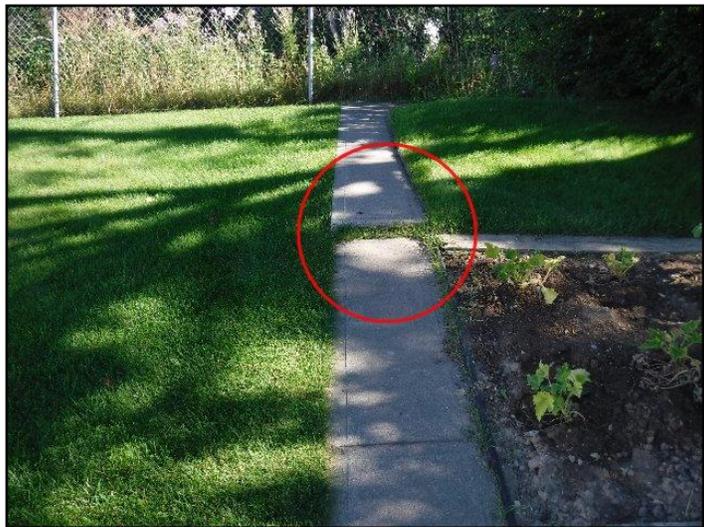
15. Condition: • Uneven (trip hazard)

31. Uneven (trip hazard)

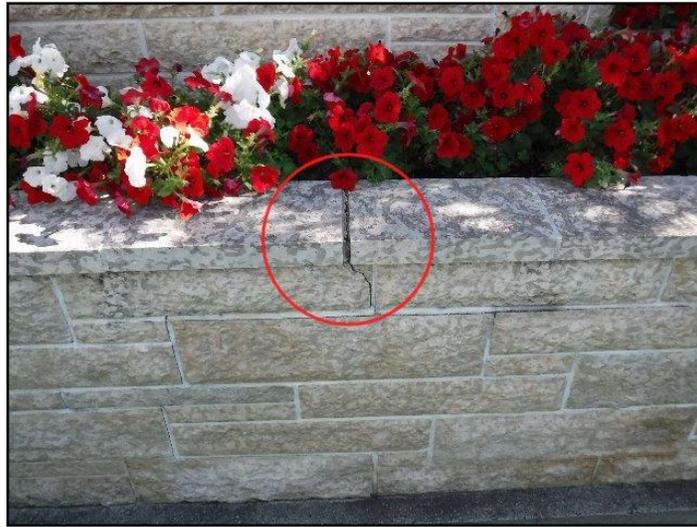
16. Condition: • Mortar - deteriorated, missing

32. Mortar - deteriorated, missing

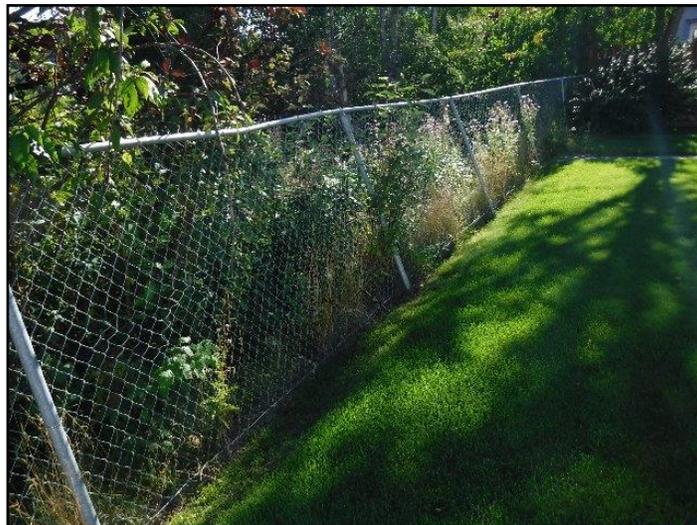
17. Condition: • Leaning

33. Leaning

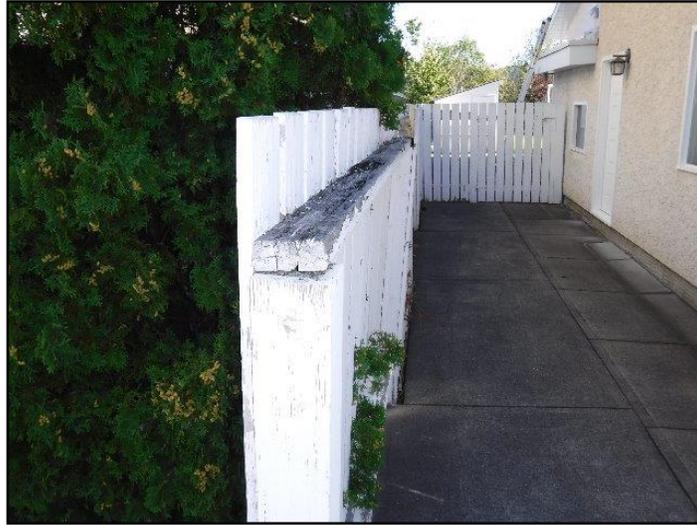
18. Condition: • Rot

34. *Rot/loose*

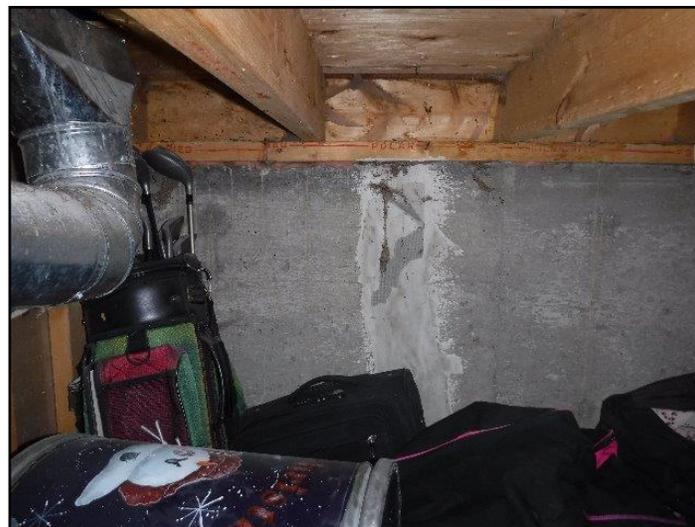
Typical minor foundation crack with prior repair or patch is present at front of basement. No evidence of current leakage or moisture noted, recommend monitoring and professional crack repair if necessary.

35. Typical minor cracks

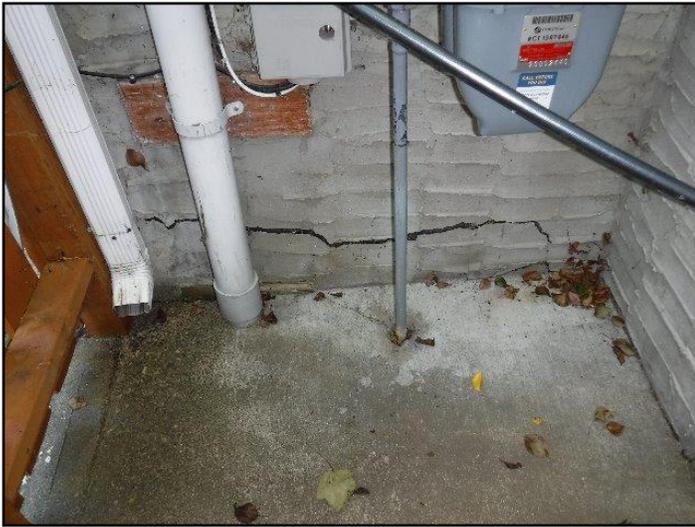
20. Condition: • Parging damaged or missing

36. Parging damaged or missing

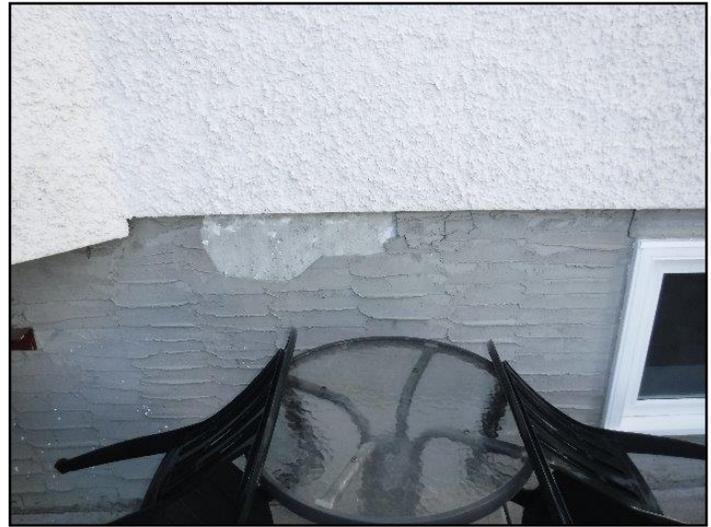
37. Parging damaged or missing

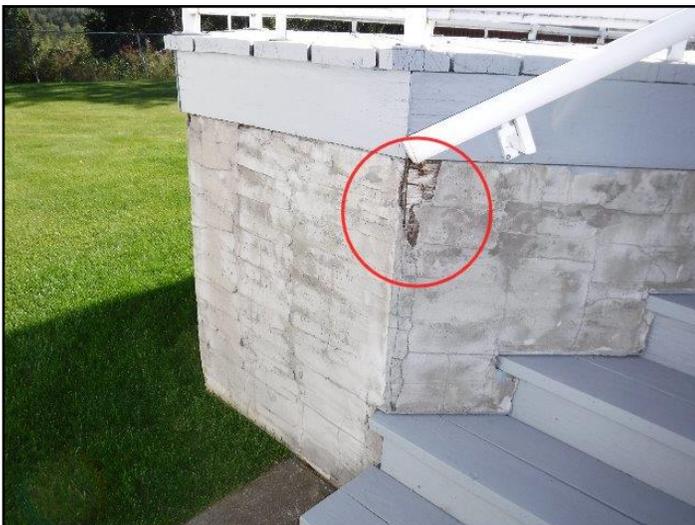
38. Parging damaged or missing

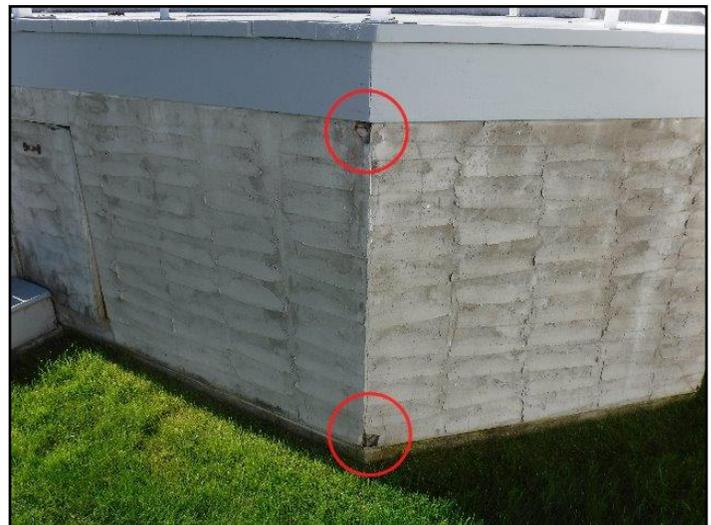
39. Parging damaged or missing

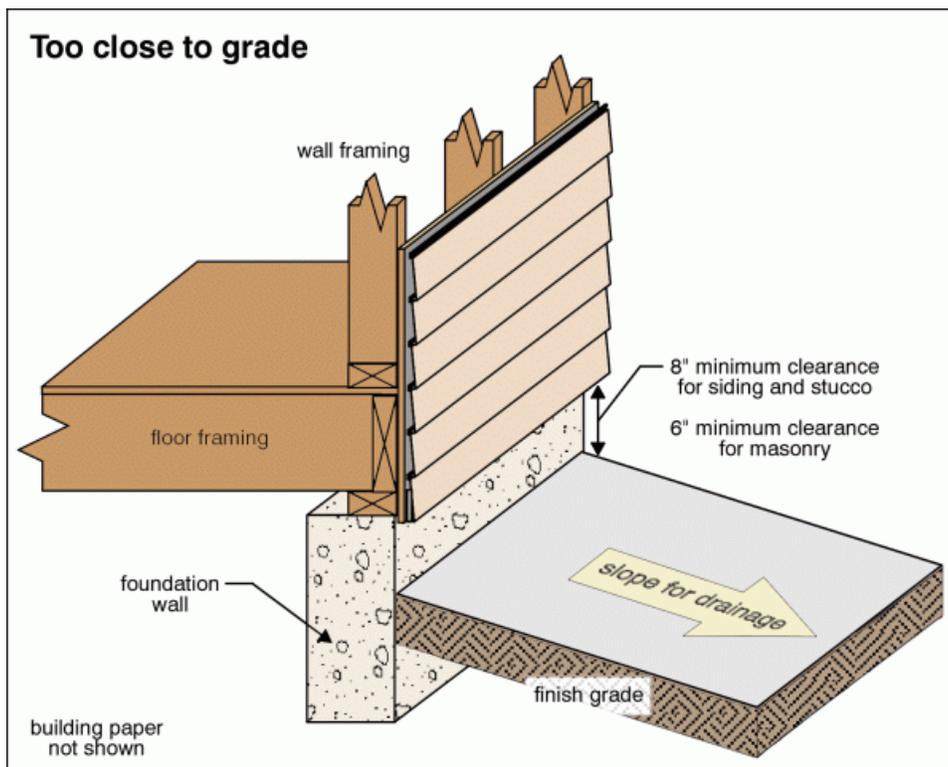
Wood frame walls of North addition are too close to grade and water coming through exterior deck above is pooling against wall promoting rot. Recommend contractor repairs or improvements to avoid further damage.

40. Wood too close to grade

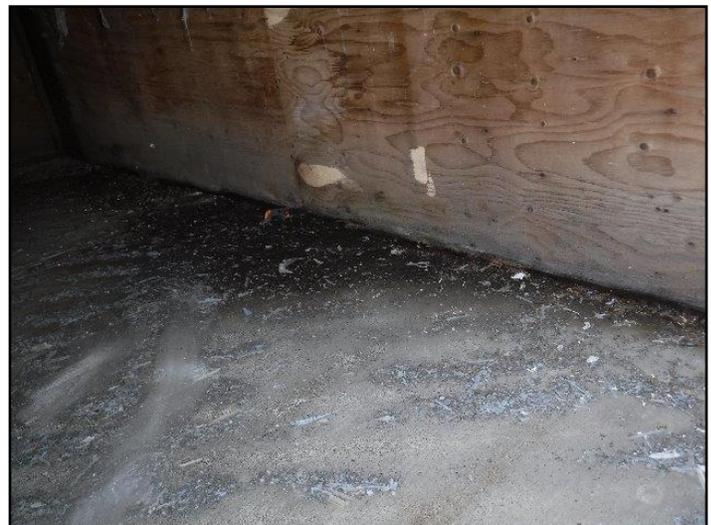
41. Wood too close to grade

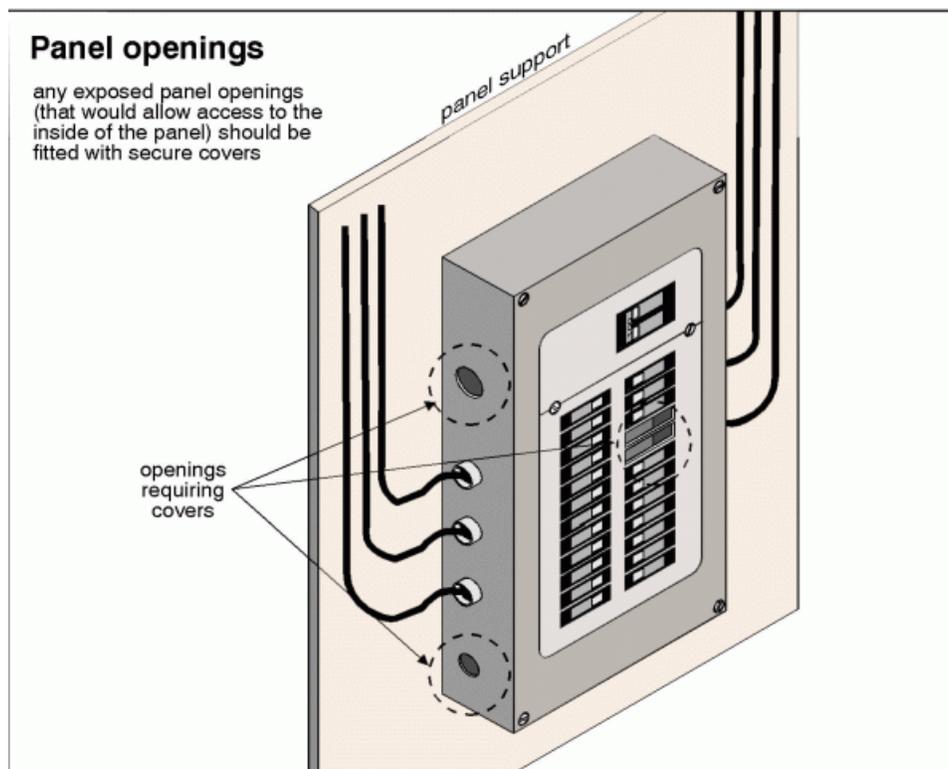
23. Condition: • Openings in panel

43. Openings in panel

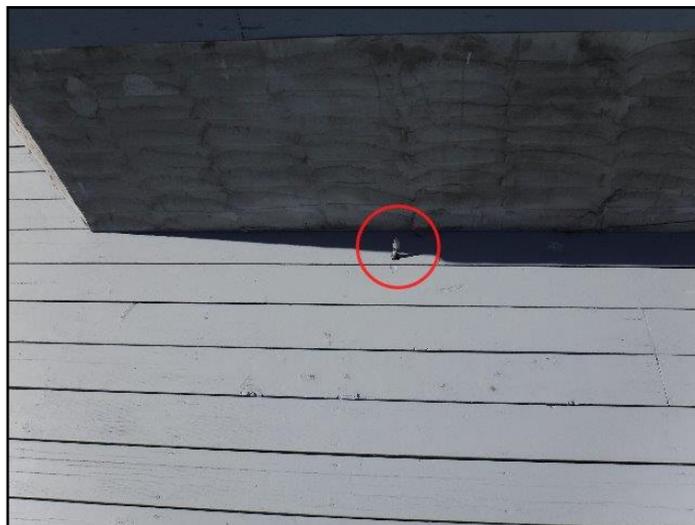
24. Condition: • Abandoned wire

44. Abandoned wire

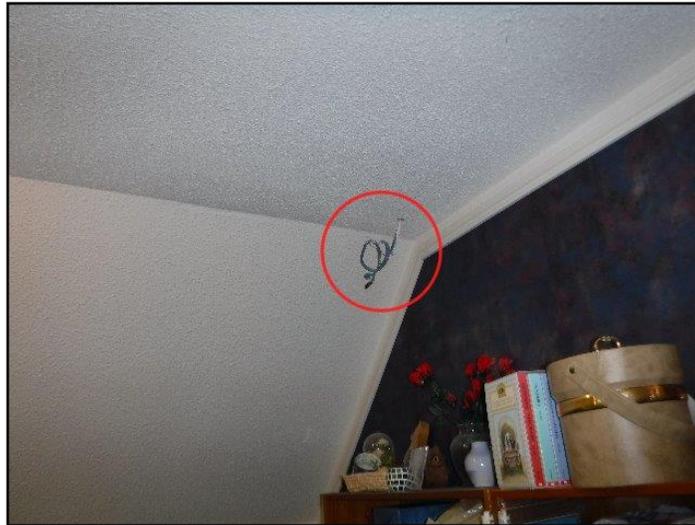
25. Condition: • Abandoned wire

45. Abandoned wire

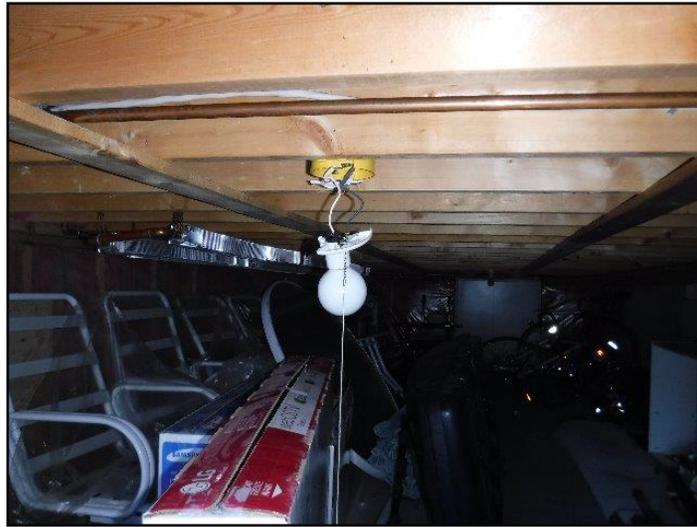
27. Condition: • Loose

47. Loose

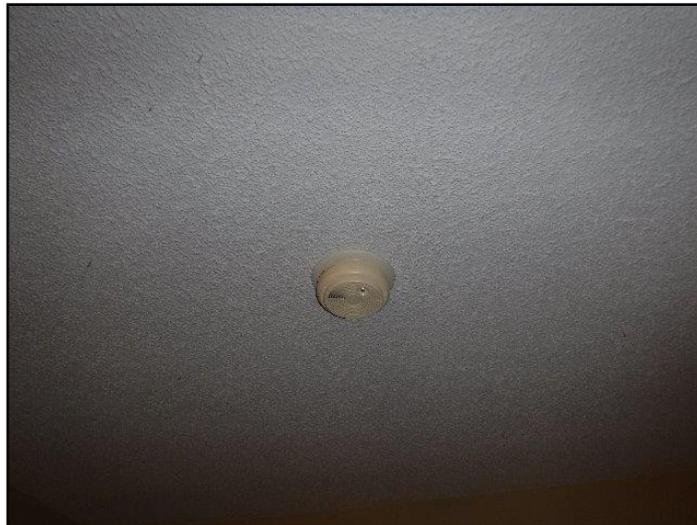
28. Condition: • Old

48. Old

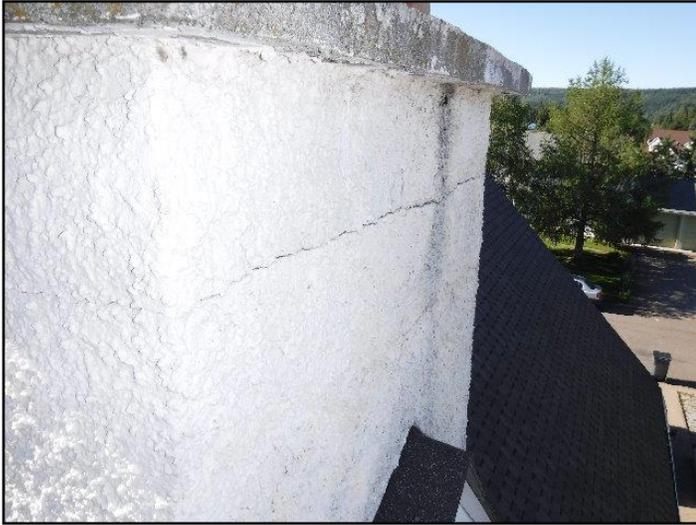
Chimney caps are cracked and causing moisture penetration and cracking of stucco beneath. Recommend mortar wash or sealing of cracks and repairs to stucco as needed.

50. Cracked/moisture penetration

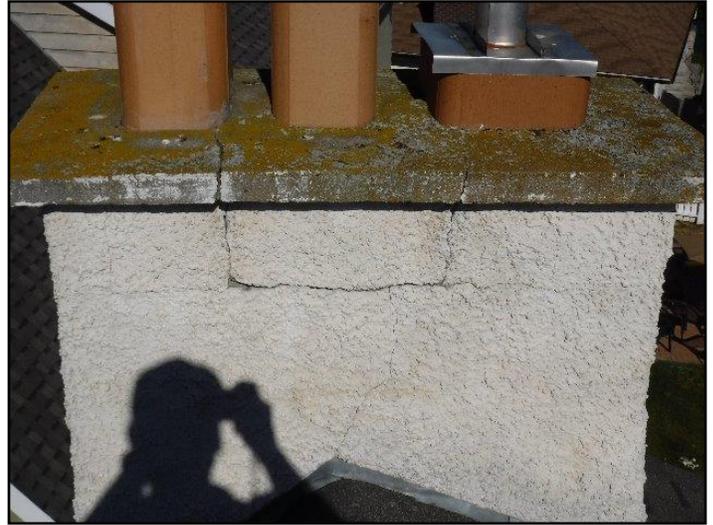
51. Cracked

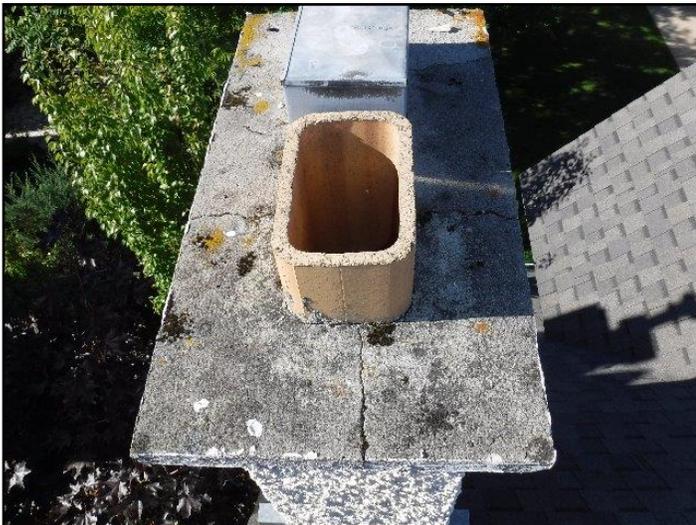
52. Cracked

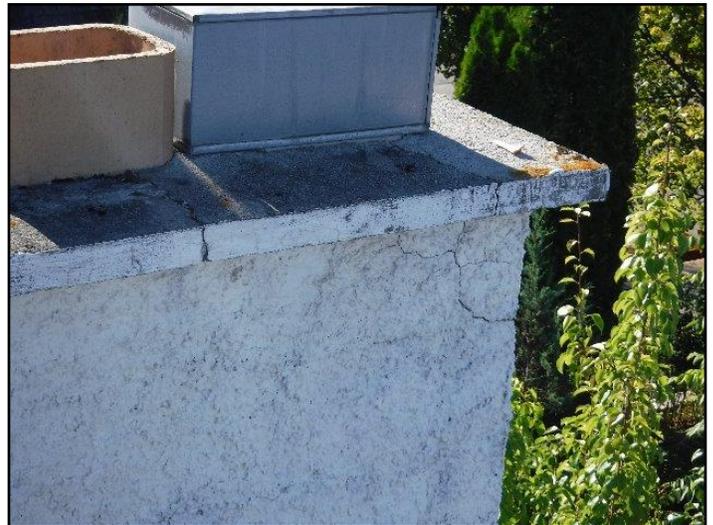
53. Cracked

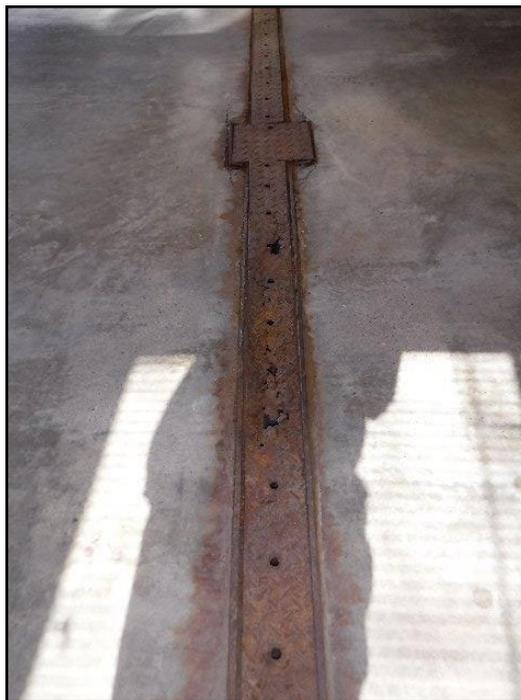
33. Condition: • Rusted

64. *Rusted*

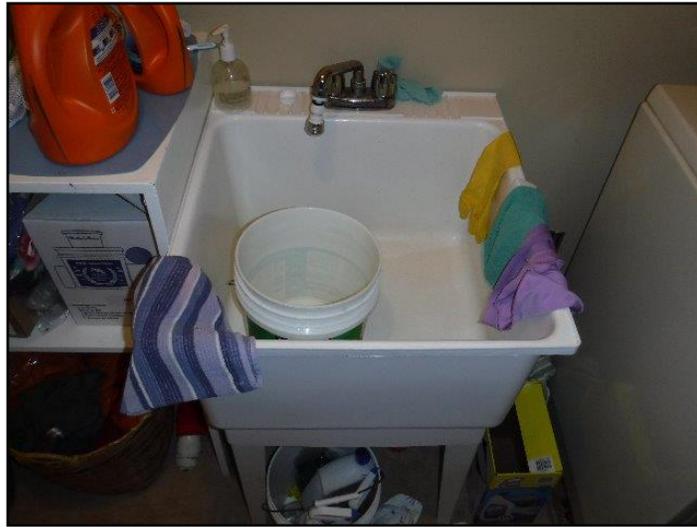
34. Condition: • Loose

65. Loose

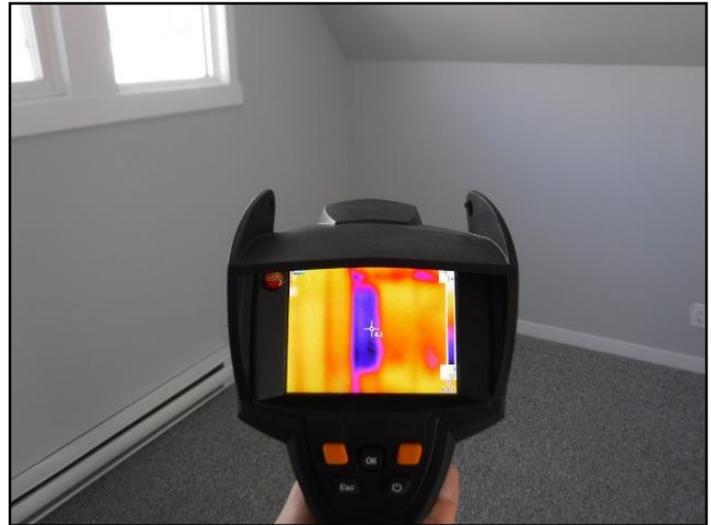
35. Condition: • An anomaly what appears to be missing or water damaged insulation was detected with thermal camera in second floor bedroom walls. Water damage from previous roof leakage is suspected to have occurred in these areas, recommend having further evaluation or testing for concealed damage before removing subjects on property.

67. Southwest corner of bedroom

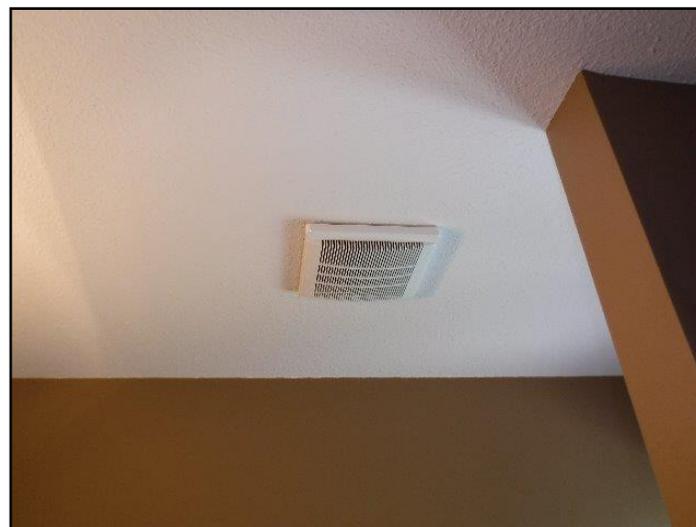
36. Condition: • Noisy

68. Noisy
