Your Inspection Report

1234 Sunshine Place
Okanagan, BC V1B 2Y3

INSPECTION DATE:
Sunday, May 5, 2013

RE: Report No. 1597, v.3
1234 Sunshine Place
Okanagan, BC
V1B 2Y3

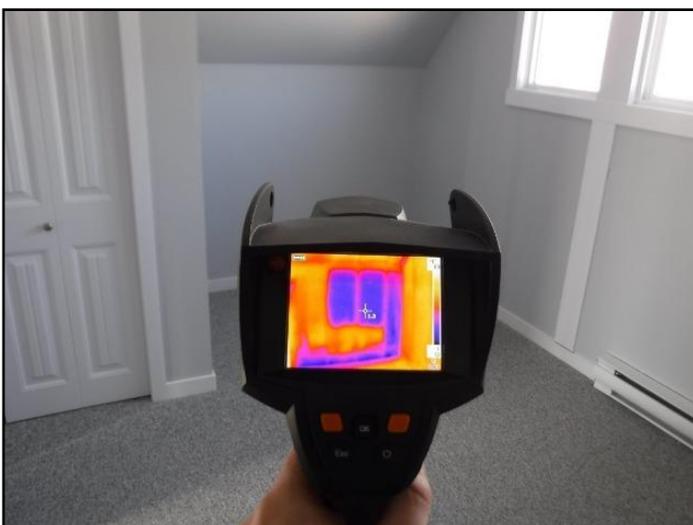
8. Southeast corner of bedroom

Condition: • An anomaly what appears to be missing or water damaged insulation was detected with thermal camera in second floor bedroom walls. Water damage from previous roof leakage is suspected to have occurred in these areas, recommend having further evaluation or testing for concealed damage before removing subjects on property.

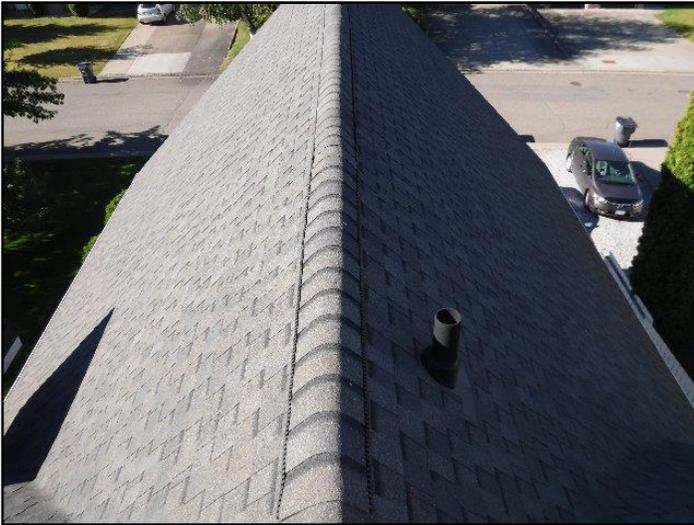
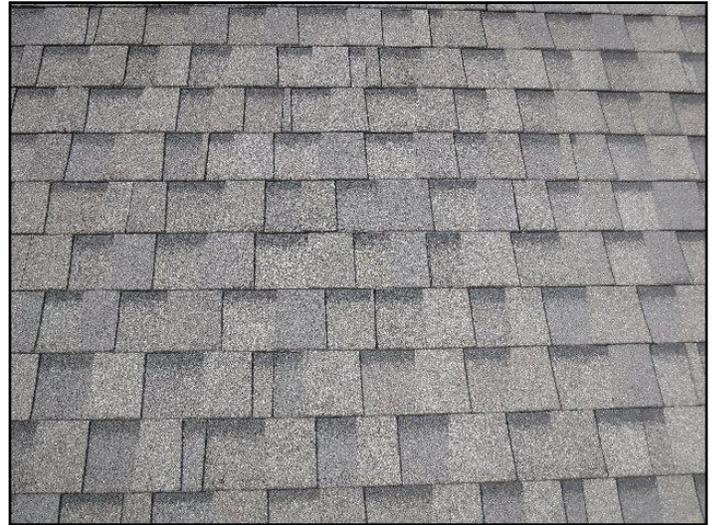
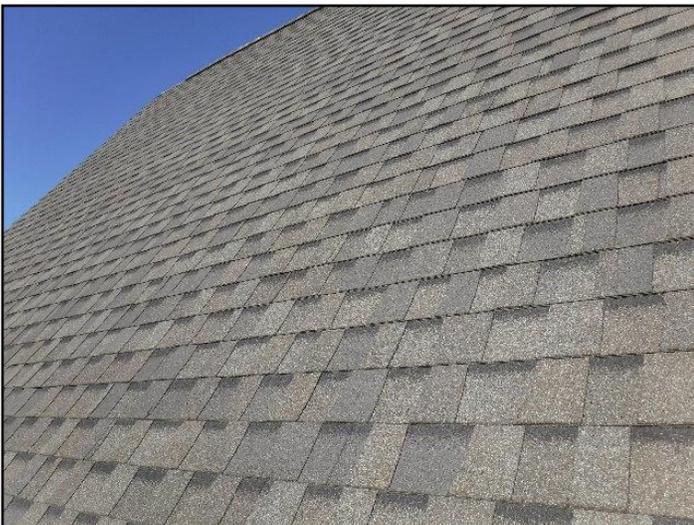
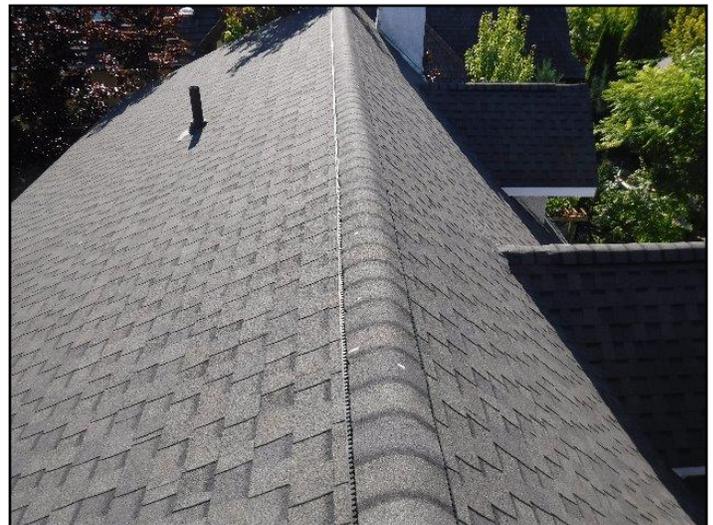
Shingles on roof are approx. 2 years old and in good condition, no performance or installation issues noted. Typical life expectancy of fiberglass mat shingles is 30 years.

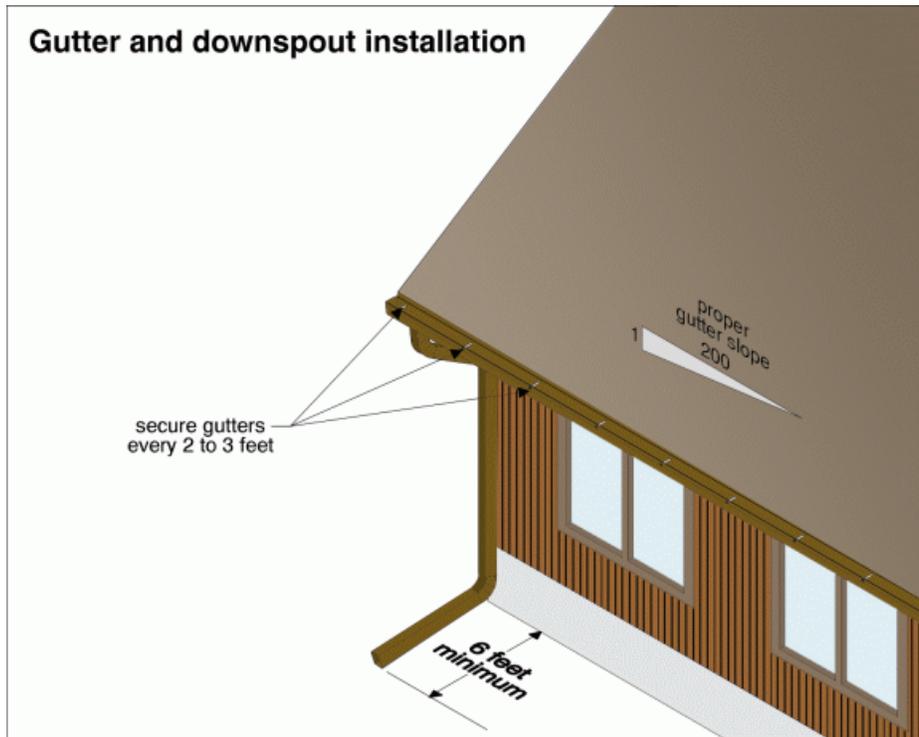
This downspout is causing water damage to foundation parging and wood steps, recommend re-routing away from building.

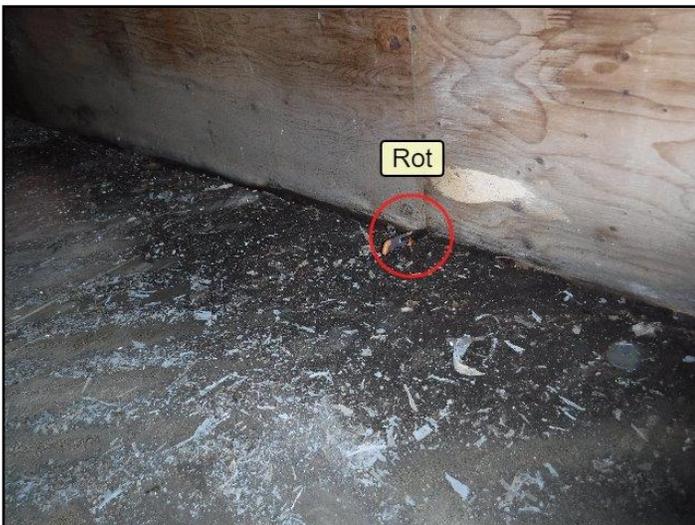
40. Wood too close to grade

Wood frame walls of North addition are too close to grade and water coming through exterior deck above is pooling against wall promoting rot. Recommend contractor repairs or improvements to avoid further damage.

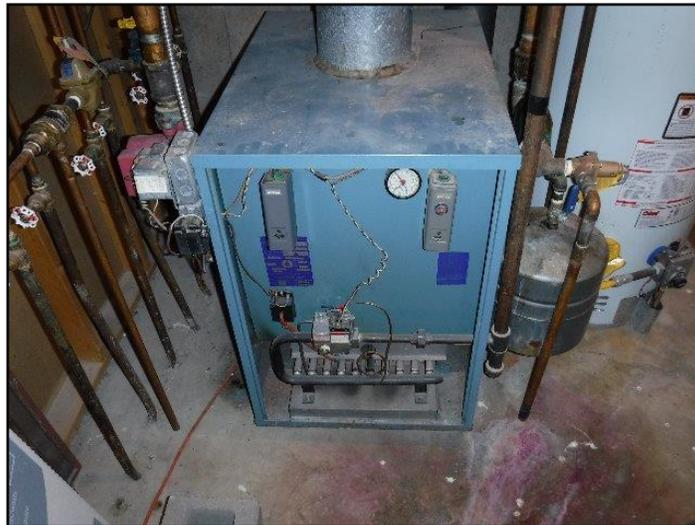
49. 36 years

Gas boiler heating system is past typical life expectancy, heating was tested and no performance issues were noted. Recommend further evaluation of unit by heat tech and replacement if necessary.

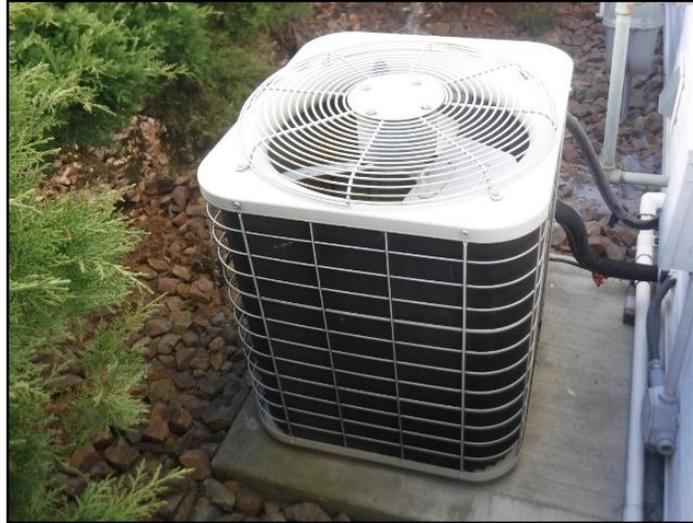
55. 23 years

Air conditioning unit is past typical life expectancy, recommend budgeting for replacement.

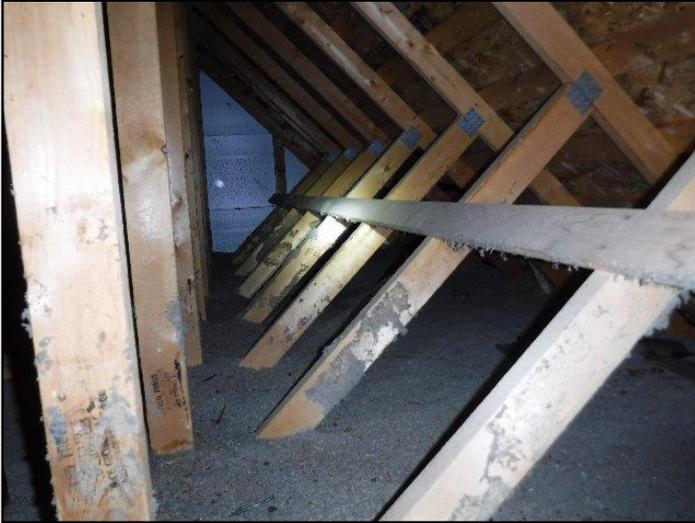
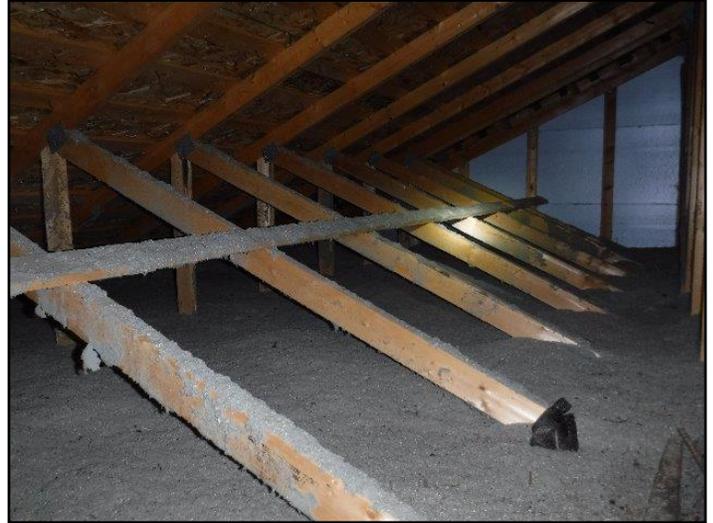
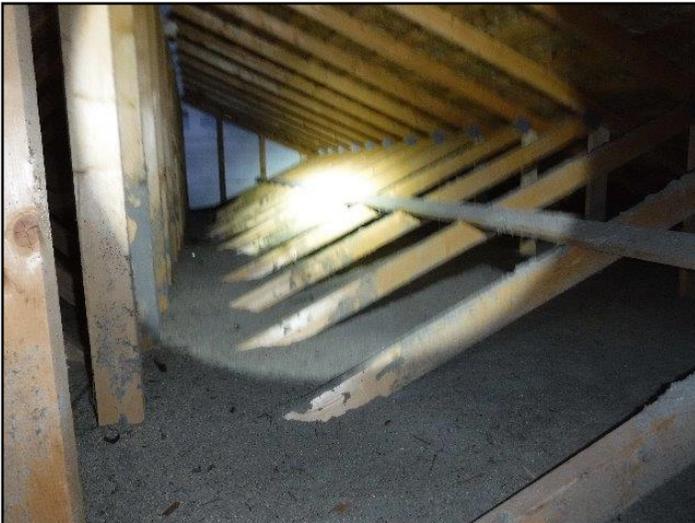
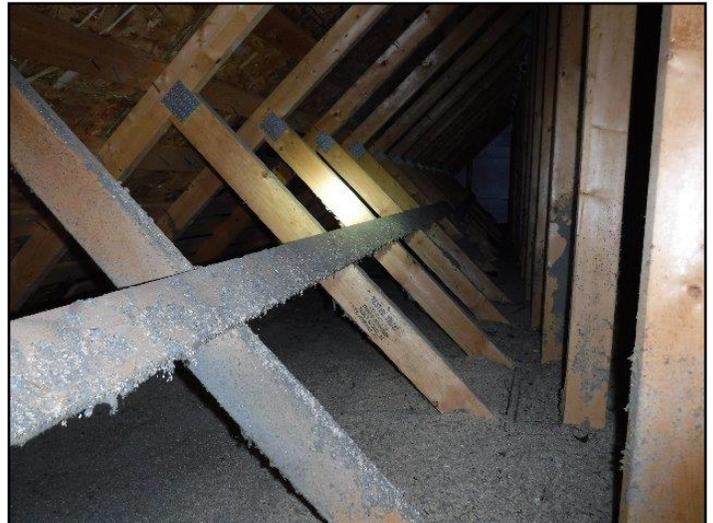
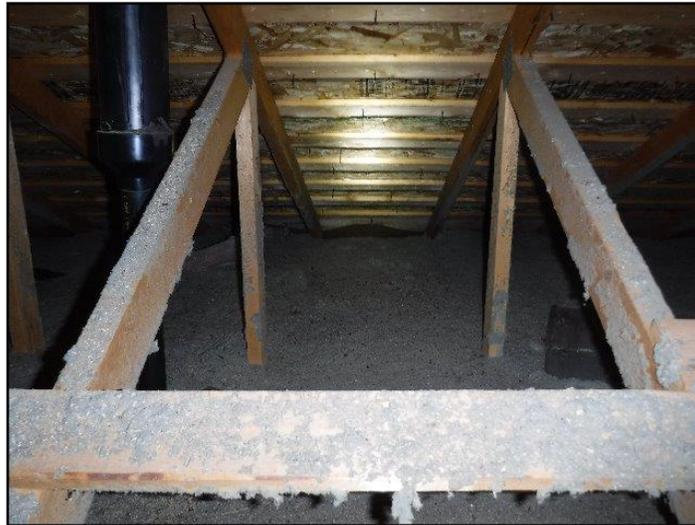
General: • Attic is dry, well insulated and ventilated. No performance issues noted in attic.

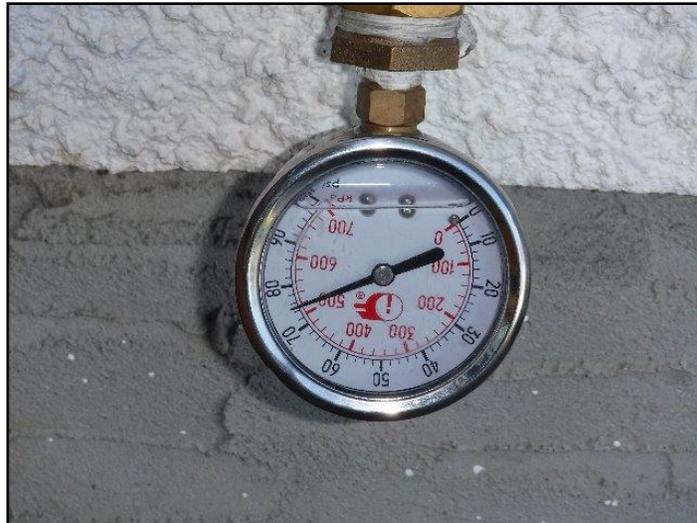
62. Good 75psi

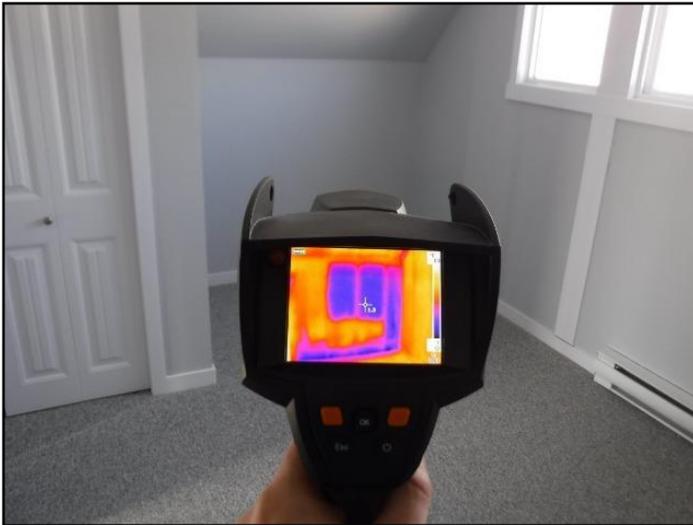
66. Southeast corner of bedroom

35. Condition: • An anomaly what appears to be missing or water damaged insulation was detected with thermal camera in second floor bedroom walls. Water damage from previous roof leakage is suspected to have occurred in these areas, recommend having further evaluation or testing for concealed damage before removing subjects on property.

Implication(s): Chance of water damage, rot and mold, damage to structure

Task: Further evaluation

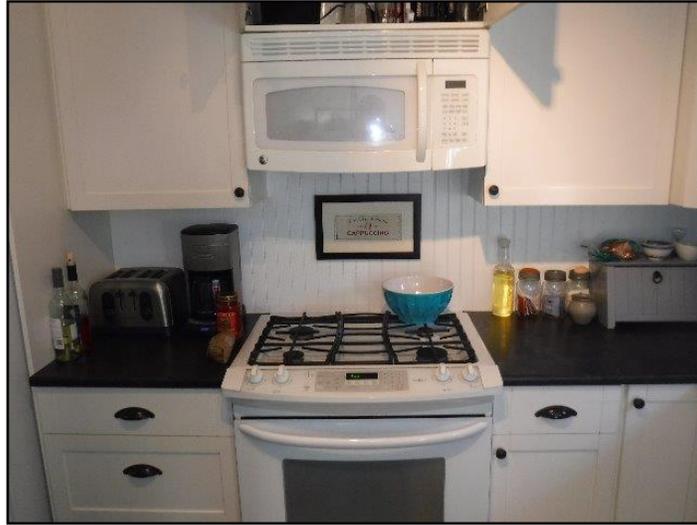
37. Condition: • Not vented to exterior

Location: Basement Suite Kitchen

69. *Not vented to exterior*

Recommend venting to exterior or installing electric range/oven appliance.
